Engineering Analysis

The conclusion reached in the Condition Assessment for the Going-to-the-Sun Road states that a majority of the Road is in need of extensive rehabilitation in order to be responsive to the issues of public safety, environmental concerns, preservation of historic features and natural resources, socioeconomic impacts, transportation needs, and overall visitor experience. Our findings support previous analyses of the Road that also recommend expediting rehabilitation efforts in order to ensure the integrity of this National Historic Landmark for future generations.

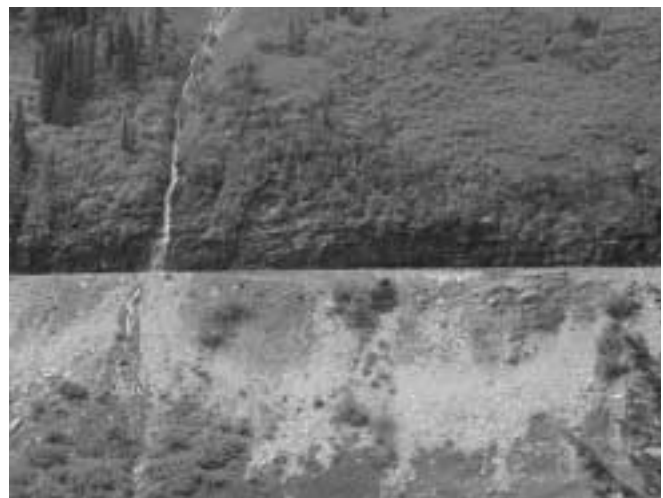
Figure 59: Weeping Wall

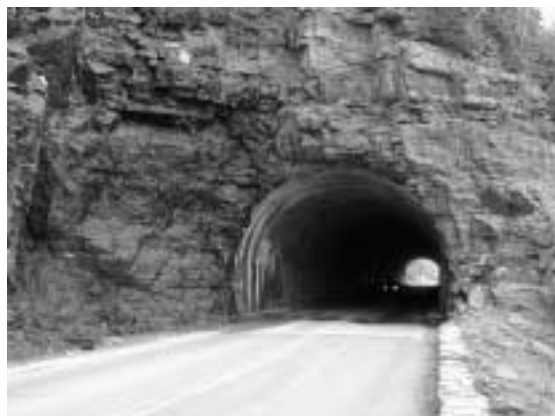
Figure 65: East Tunnel

- **East Tunnel: MP 33.2.** This concrete lined tunnel is 408 feet long by 21.5 feet wide, and is in good condition. The stone masonry guardwall and retaining wall approaches to the tunnel are in need of work as shown in Figure 65.

- **East Tunnel Segment: MP 32.0 to 33.4.** Drainage across the road occurs at MP 33.4 (Sta. 830) and should be corrected with an RCP pipe under the roadway and outlet protection. Scaling of the rock cuts above the roadway is needed in the area of MP 33.3. The roadway for about 150 feet is settling and requires template rehabilitation in the vicinity of MP 32.9 (Sta. 818) along with the rebuilding of the guardwall in this area on a new footing. A roadway slab anchored with micropiles and tiebacks appears to be the best solution; however, a geotechnical investigation should be conducted to support the design. Roadway shoulder and rock wall undermining and deterioration east of the East Tunnel, approximately MP 33.3, threatens the roadway cross section. This section of roadway (about 400 feet in length) exhibits continuing and progressive erosion and deterioration. Significant sections of stone guardwall have been damaged and destroyed by this erosive action. Guardwalls at MP 32.2 (Sta. 818), MP 33 (Sta. 822+50), MP 33.2 (Sta. 826), MP 33.3 (Sta. 862), and MP 33.4, all need significant repair including reconstruction on footings or slabs, preferably with an avalanche resistant guardwall in

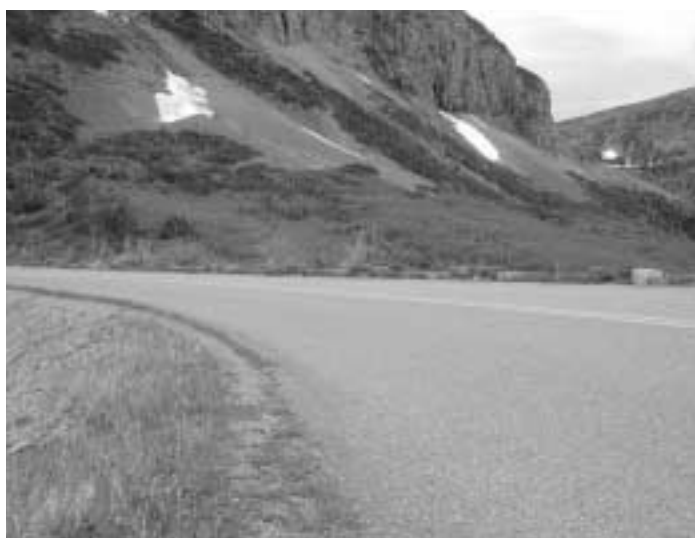
Slope Stability: Slopes above the roadway on the east side of Siyeh Bend are raveling due to surface erosion on the steep soil cuts. Other than this and some debris flows, most of this section requires little slope stability remediation.

Figure 67: Siyeh Bend
